**Report: Disabled Access for James Edoff Memorial
Bandstand**

Prepared for the City of
Oakland

Revised 5/8/07

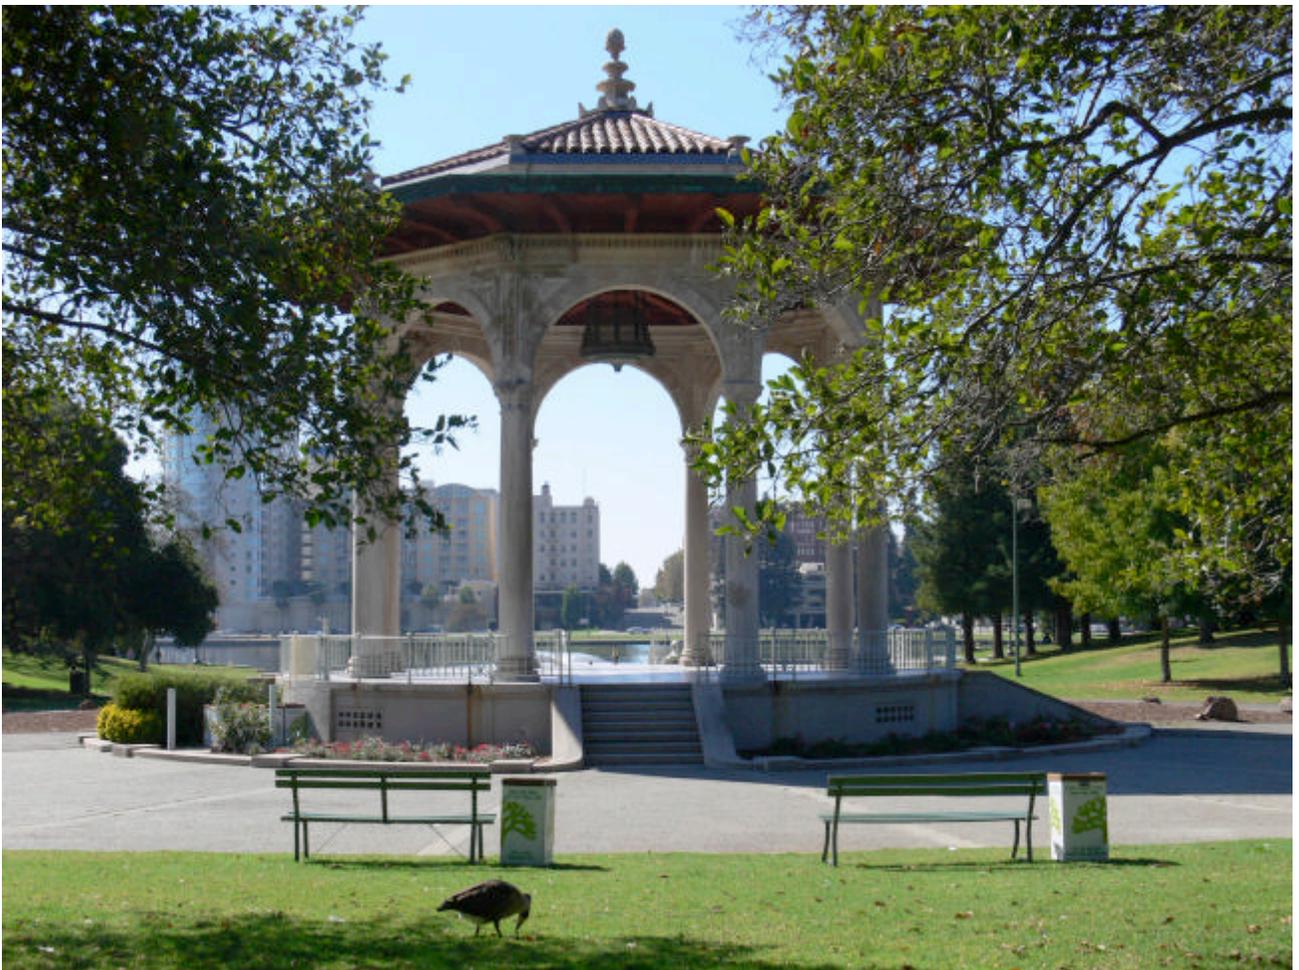
Recent photo shows concrete paving on the North side of the bandstand, and areas of redwood bark that replace former paving on the sides. Historic shrubs have been partially replaced with lower-growing flowers.

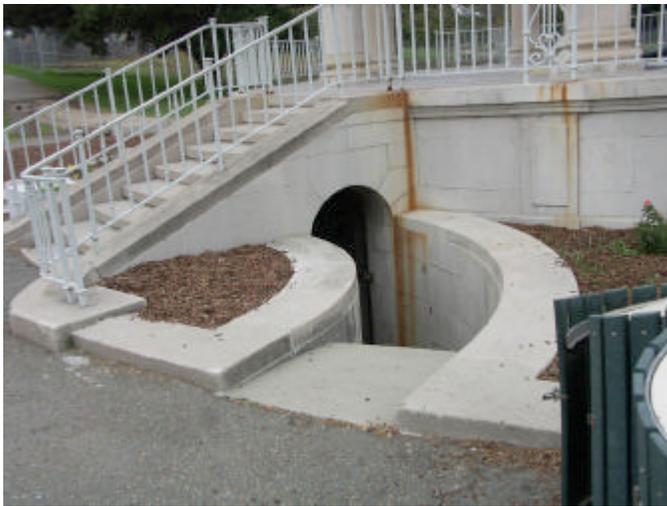
South stair and stairs to basement. Note rust stains on walls.

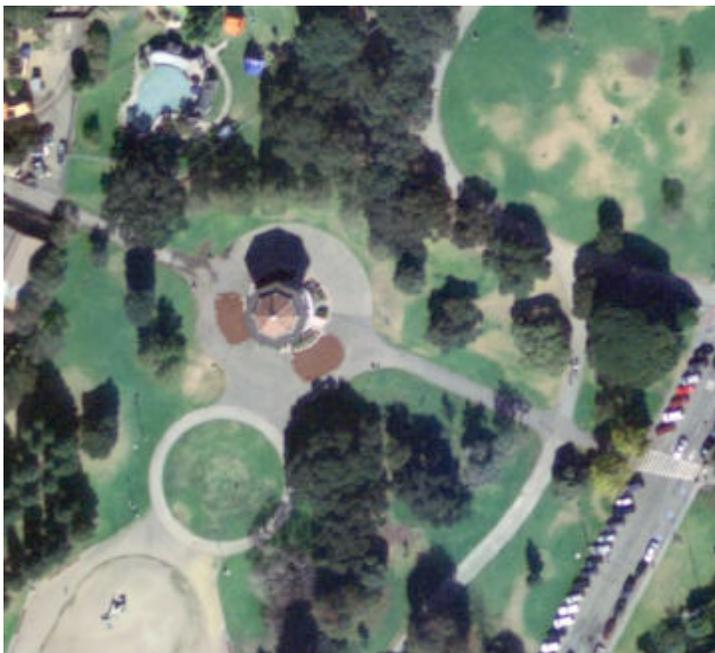
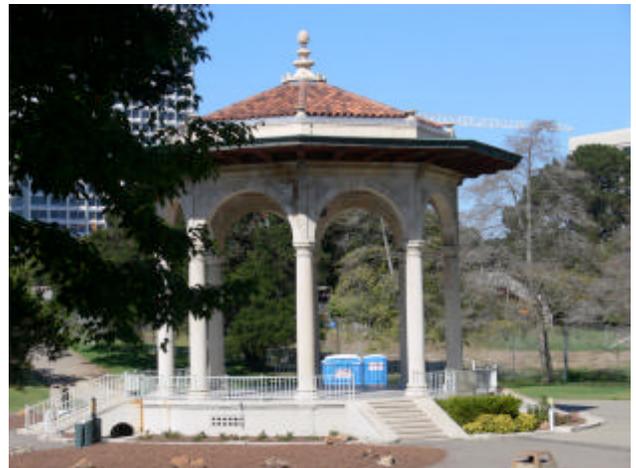
View from SE. Portable toilets are brought in for special occasions. South stair has a handrail; the other stairs have no

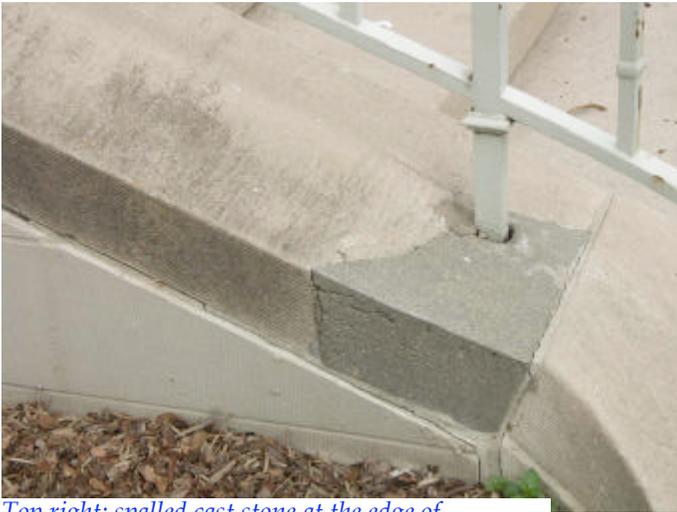
Top right: spalled cast stone at the edge of bandstand floor. Rusted round pins may be from a previous repair.

New spall repairs will involve cutting back the existing feather edge to a depth of $\frac{1}{2}$ " or more and installing stainless steel or nylon reinforcing anchors into the adjacent sound cast stone before filling in with a carefully formulated composite material.

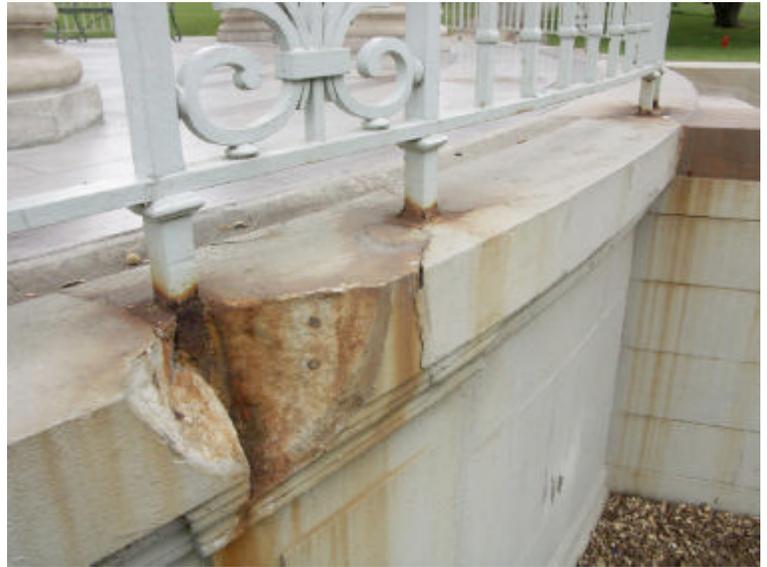
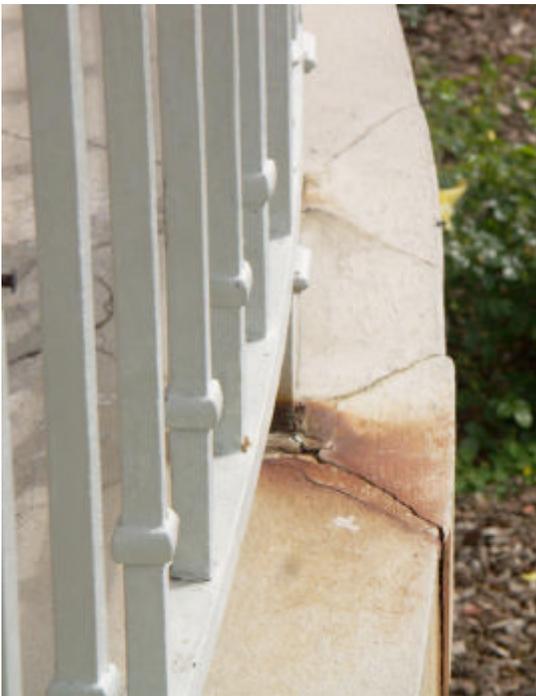
Above: repaired cast stone doesn't match color or texture of original.

Below: previously repaired spalls about to fail.

Rust stains and spalling deface the base of the bandstand. Both the stains and spalling are caused by corrosion of the metal support posts of the existing historic rail, where the posts are embedded into the cast stone. Water runs down the posts and gets into the joint, where it rusts the metal. The rusted metal expands, cracking the cast stone and causing it to spall.

The spalls and iron stains have been repaired previously, possibly as part of the 1993 seismic upgrade. The spall repairs seem to have involved the gluing of some sort of fabric to the surface of the cast stone. The entire cast stone edge was then painted so the repairs would not be so obvious. The textured cast-stone walls below the bandstand floor have also been painted, possibly to disguise the rust stains as well as to hide ongoing graffiti.

Most of the repaired spalls are starting to fail again, and new rust stains disfigure the appearance of the bandstand.

A more permanent repair to address the underlying cause of the problem might involve cutting all the existing rail support legs below the existing collar, removing the rail, drilling out the existing rusted legs, and replacing them with new non-rusting material (such as stainless steel) grouted into the cast stone and underlying concrete. While the rail is removed it could be sent out to be hot-dipped galvanized to protect it from further corrosion before it is repainted and re-attached to the new legs. The existing white rails appear as black in most historical photos (see photo, this page), hence painting the rails black at this time might be appropriate.

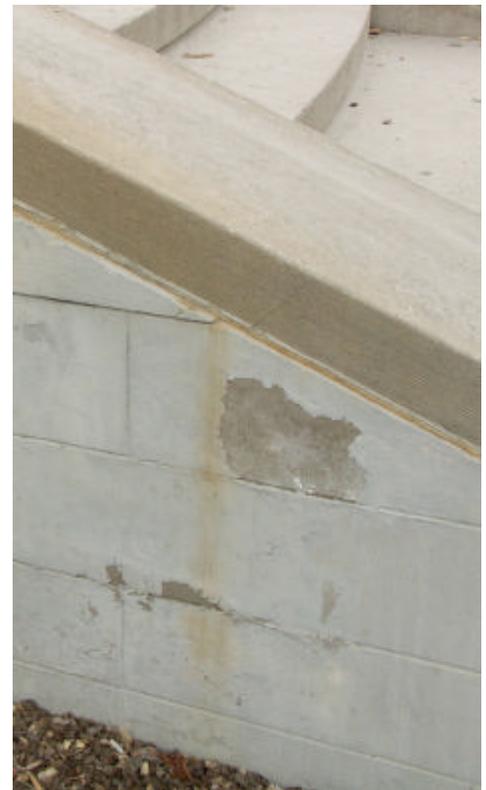
Painted cast-stone wall. The original material is exposed where paint is chipping off. Cast-stone stairway is unpainted.

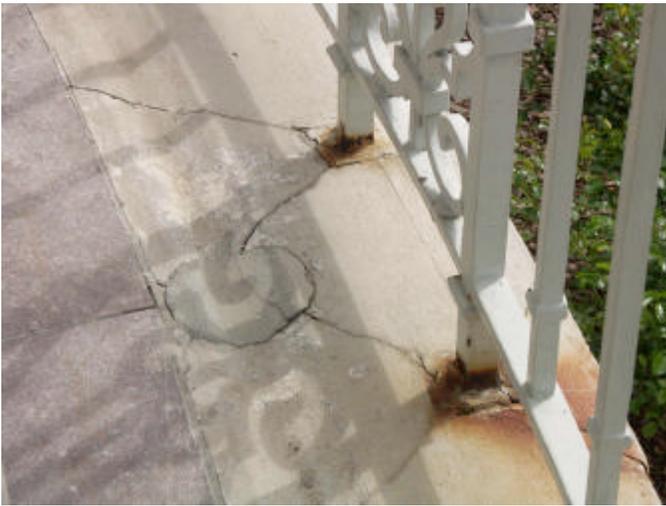
Gutter with filled-in drain at the floor of the bandstand.

The bandstand floor was constructed with integral gutters just inside the rail. Each of the four gutters (one for each quadrant) had two drains that presumably led to a concealed rainwater leader in the basement. These drains have been filled in and are not currently in use. It is not known whether this contributes to the existing rusting and spalling problem.

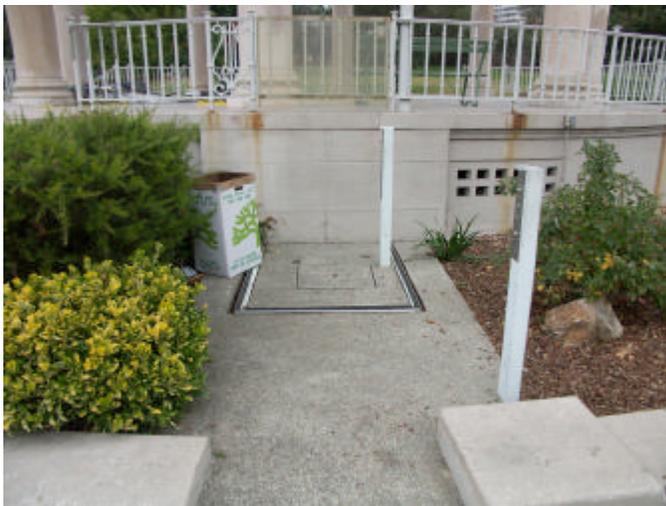
Existing non-functional underground lift. The City is currently responding to a lawsuit relating to this lack of accessibility.

In 1995, a wheelchair lift was installed in an underground pit on one side of the bandstand. To accomplish this, about 4' was cut out of the historical curb to allow for the installation of a new concrete pad leading to an underground lift. Other than the curb cut and the paved walkway, the existing lift is relatively inconspicuous (as seen in the photo at left). Only the two posts with the controls are visible.

However, the lift is no longer operational due to water damage, meaning that the structure is not in

compliance with ADA accessibility codes. The City is currently responding to a lawsuit relating to this lack of accessibility.

The existing lift was not installed in the location indicated on the plans, which show the lift centered on the basement window. It was moved to one side, closer to the column. The column is visible in the photo at lift. This means that the upper gate does not have the clearance required by code on the floor of the bandstand, because the column is in the way.

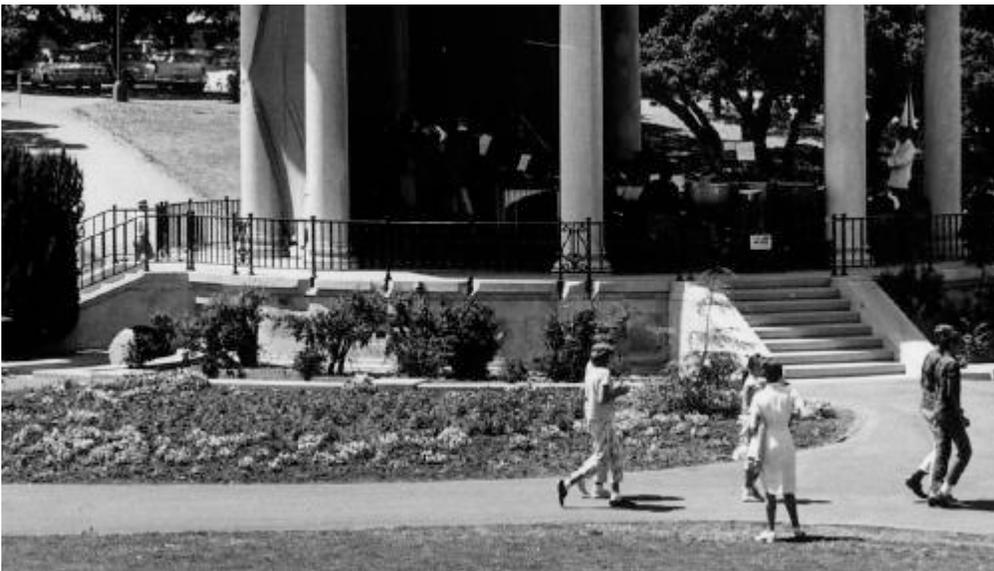
Historic photo from the early 1960's showing planting in the area currently occupied with redwood mulch, and existing black railings. Note also the extensive open spalling at the railing attachments.
