**Report: Disabled Access for James Edoff Memorial
Bandstand**

Prepared for the City of
Oakland

Revised 5/8/07

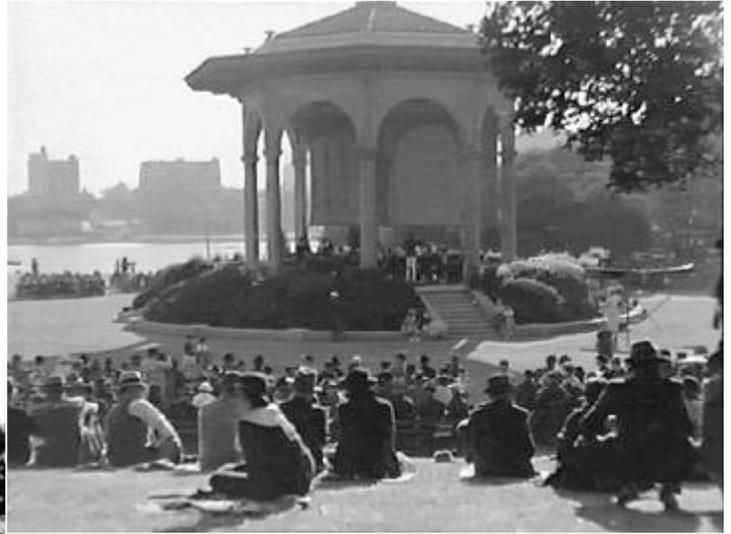
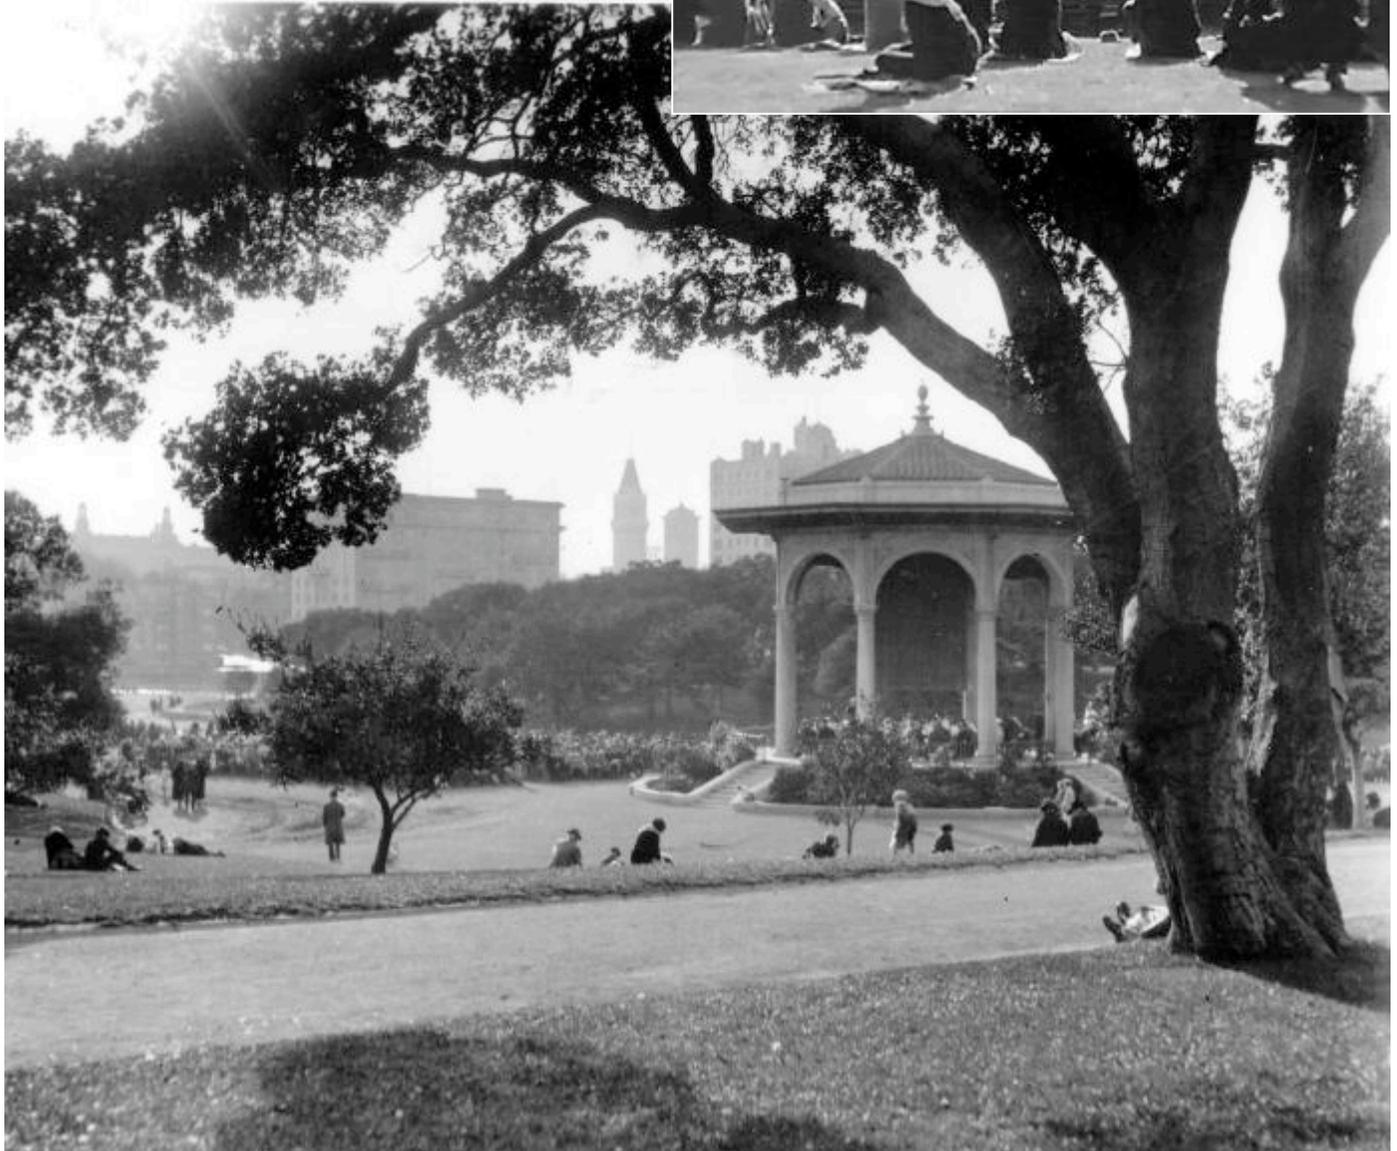
Historic photos show asphalt or gravel paving in a complete circle around the Bandstand. Path in foreground, through the oak trees, has been removed.

Note shrubs next to Bandstand. Paving appears to be compacted gravel (not concrete).
